# “Eureka!”

## We’ve Got Leaks and Know How to Solve Them

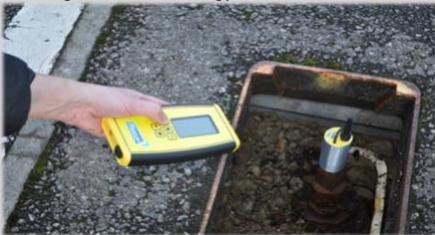
**Phocus3** is an acoustic noise logger that automatically detects and localizes leaks on any water distribution network. The loggers are deployed underground on existing assets and utilize low power radio and/or infrared communications without the need for costly above ground technology.

The loggers listen for any potential leakage. The data is retrieved and viewed daily, which can be easily downloaded to any PC for further analysis if required.

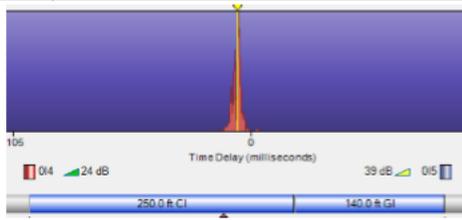
**Enigma** is a non-real time correlating system that combines noise logging and correlation into one system.

It is the preferred technology for assisting with the pinpointing process of leak confirmation on complex, noisy, and busy areas within the water system.

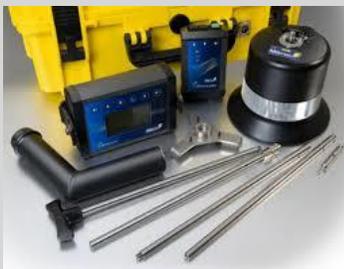
**Mikron3** is a wireless ground microphone and listening stick kit designed for leak surveying, pinpointing and confirmation.

All 3 pieces of equipment listed above were vital in the successful leak investigation of the Eureka Springs Water System.

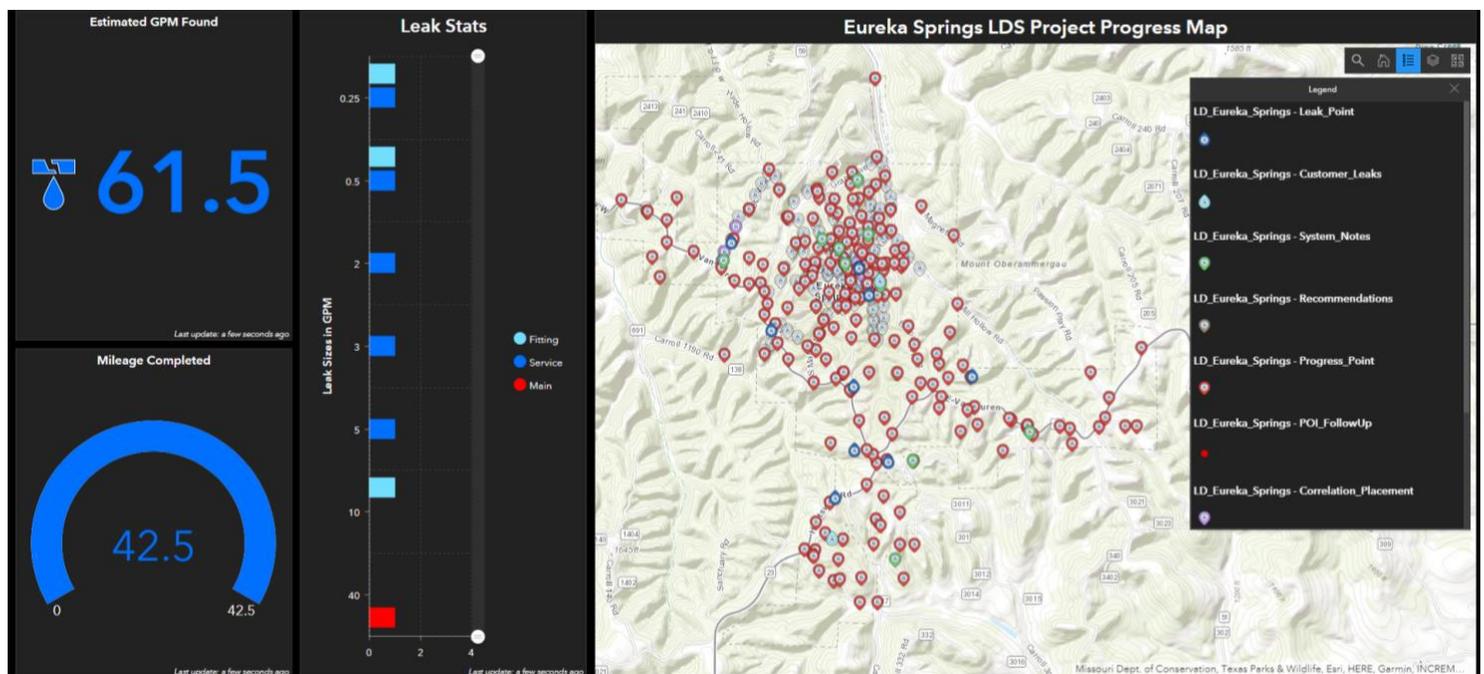
The Esri dashboard featured here was available to the customer throughout the project and depicts the completed statistics and progress map. This is a great tool for quick vision into the project current status and findings.

After coordination with the client for preferred scheduling and preparation, MWAM mobilized their three-technician leak detection team to the City of Eureka Springs and held a project kick off meeting with the client. The meeting helped to further inform the MWAM project field team of the system's current condition and to develop the plan of action for how to attack the leakage issues from a field investigation perspective. MWAM then hit the ground with an initial investigation of the system using acoustic sounding and visible observations to identify any indication of leak evidence. The initial survey included the deployment of 121 acoustic Phocus3 noise loggers, as well as the sounding of 1,160 fittings with the Mikron3 listening stick. As an added benefit during the initial surveying portion of the investigation, two customer leaks and ten system notes were identified, including two possible theft situations. Once the initial survey of the system was underway, correlation leak confirmation along with ground probing and microphone techniques were used to pinpoint the exact areas where leakage was occurring. These areas were marked for client follow up so that appropriate repairs could be made. A total of seven different correlations were conducted throughout the system to assist with the confirmation of leakage on nine separate leak locations. The largest leak located during the investigation was roughly 40 GPM! The initial survey and confirmation process of the leak investigation spanned over nine working days, utilizing 198-man hours, and covered a total of 47.5 miles of water distribution system.
